Order No.: DD+DIS108.01E

ADC Solo
Type 5155

Laser Diodes with wrongly connected Wires at Peltier Element

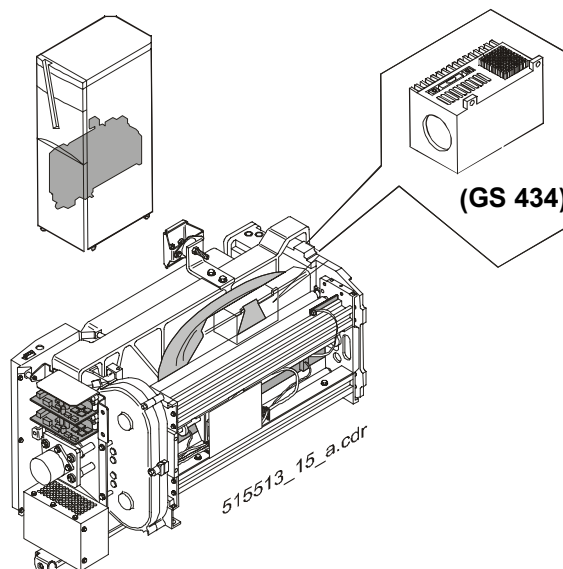
Figure 1

Symptom: The Peltier element at the laser module (GS434, see Figure 1) - intended for cooling the device - may cause a heating effect, which is responsible for sporadic artifacts of the machine.

Defect: With an uncertain amount of laser modules the wiring of the Peltier element has been confused. This causes a heating effect.

Due to the heating up the nominal power of the laser varies. As an example the following power variations can occur during a scan process:

23 mW
23 mW
13 mW out of range of tolerance!
23 mW
22 mW
11 mW out of range of tolerance!
23 mW
23 mW

These variations cause artifacts in the picture.
